## Preliminary Failure Examination of a Plastic-Injection Mould Part

*The paper studies the failure of a mould-part for the hot-forming of plastics, by injection. The mould's component was manufactured from AISI H13 and was intended for the production of plastic cups for cylindrical aluminium cans, used for coffee packaging. The tool belongs to a system that produces simultaneously four pieces per cycle. It exhibited a single uniform through thickness crack, after five millions working-cycles, where the lifetime was expected to be ten millions cycles. The paper refers to the preliminary examination of the failed tool surfaces. Data concerning the manufacture, processing and operation of the part were collected and a complete photographic file was created. Non-destructive testing was performed, including hardness measurements, inspection with fluorescent penetrating fluids. Chemical analysis was carried out and the material used to make the tool was identified. The paper presents conclusions on the crack initiation and propagation and the main causes that led to the premature failure.*

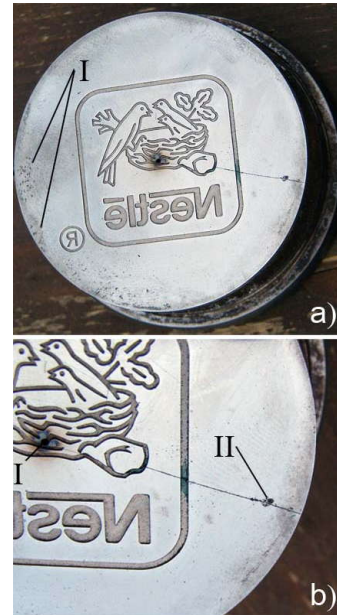
**Fig.1.** Tool's face (pressing surface) : (a) General aspect; (b) Detail

-Grinding and polishing were made manually. Initial visual inspection of the tool revealed a cylindrical complex shape with several changes in diameter. In the centre of the moulding surface (the face), the company logo was engraved (Fig.1a). The surface appears polished but exhibits some small round corrosion marks close to the surface edge (point I on Fig.1a).

In the centre of the part, there is a hole, through which the plastic is injected into the mould for the production of the piece by pressing. Around the hole, the steel exhibits a colour alteration as if it has been burned (point I on Fig.1). This indicates that the material has been locally subjected to a significant temperature increase. After stopping the moulding machine operation, an amount of molten plastic remains in the injection hole. This plastic should be cleaned immediately; otherwise it solidifies and blocks the injection hole. Obviously the operator does not clean the part instantly and in order to remove the plastic from the injection hole, he uses a turbo gas to re-melt it. The blaze induces significant temperature increment at the specific area and thus, the steel is locally burned. As a result, the strength of the component is reduced around the plastic injection area.

The examined mould-part exhibited a single crack on the surface that was visible to the naked eye, and expanded from the injection hole towards the edge. The crack path led to partial material detachment (point II on Fig. 1b).

In addition, improper maintenance of the moulding machine was noticed. As mentioned earlier, between the operation shifts (i.e., when the machine stops completely), the remaining amount of the injected plastic was removed from the injection hole using a blaze. The local temperature augmentation caused material burning, as demonstrated by the colour variation on the surface of the component.

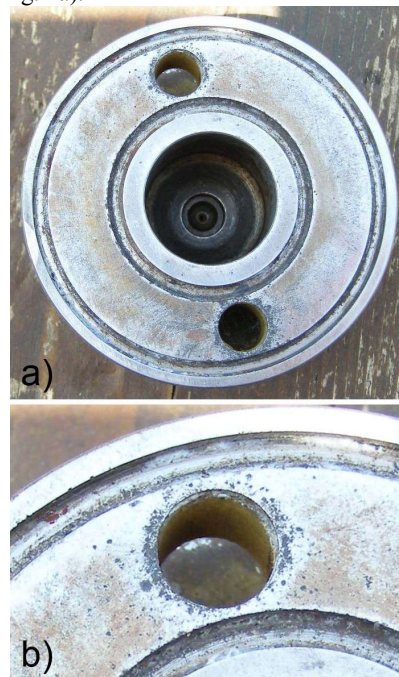
**Fig. 2.** Tool's back face: (a) General aspect (b) Detail

The 'back face' of the tool has three holes; a big one in the centre and two smaller close to the edge (Fig. 2a).

Through the central hole, the molten plastic is injected, whereas through the other two small holes the cooling mean (water) is circulated. Between one of the small holes and the injection hole, a crack was observed, propagating vertically from one end to the other. The part has also two round grooves; a shallow and a deep one. These grooves separate the cooling area from the injection area. Insulation is ensured by O-ring washers. Around the cooling holes and the grooves, significant corrosion marks were observed (Fig. 2b).

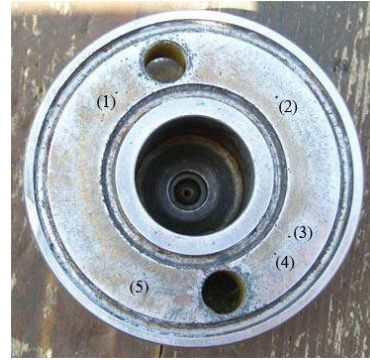
Fig. 6. The hardness measurement points

Hardness measurements were carried out at corrosion-free points of the back side of the tool (i.e. the injection area). Figure 6 presents the hardness

indentation topography. The following hardness values were obtained: (1) 49,6HRC, (2) 49,6HRC, (3) 50,5HRC, (4) 50HRC and (5) 49,5HRC. The tool presents a uniform hardness of 50HRC; i.e. the expected value after the heat treatment cycle. This indicates that the decarbonised layer was indeed very narrow and was removed during the final machining of the component. Therefore, since the designer's requirements were fulfilled, the selected heat treatment cycle can not be responsible for the failure.
