## Preliminary Failure Examination of a Plastic-Injection Mould Part

*The paper studies the failure of a mould-part for the hot-forming of plastics, by injection. The mould's component was manufactured from AISI H13 and was intended for the production of plastic cups for cylindrical aluminium cans, used for coffee packaging. The tool belongs to a system that produces simultaneously four pieces per cycle. It exhibited a single uniform through thickness crack, after five millions working-cycles, where the lifetime was expected to be ten millions cycles. The paper refers to the preliminary examination of the failed tool surfaces. Data concerning the manufacture, processing and operation of the part were collected and a complete photographic file was created. Non-destructive testing was performed, including hardness measurements, inspection with fluorescent penetrating fluids. Chemical analysis was carried out and the material used to make the tool was identified. The paper presents conclusions on the crack initiation and propagation and the main causes that led to the premature failure.*

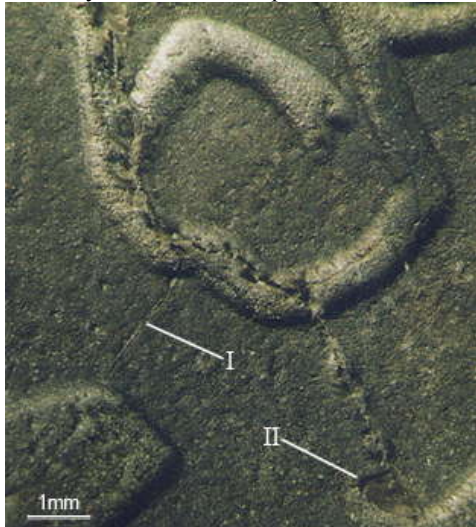
A secondary crack develops from the main crack and almost vertically to it; and extends to the mould area (point I on Fig 4,d). During the rapid crack propagation, from the internal cooling surface towards the central hole, the crack passes through the mould surface. At this point, the engraved stamp acts as an obstacle for the crack growth; whereas from the other side it acts as a preferential path of a high residual stress density. As a result, secondary cracks have been developed. Stereoscopic examination of the tool surface revealed these secondary cracks and their growth direction (point I on Fig.5). The selected magnification allowed the identification of the small fractured zone. The face of the die also presented a few areas of material loss (point II on Fig.5). This can be attributed to the fact that the face surface is strained - due to the engraving process - and therefore the crack initiation caused the material detachment.

Fig.5. Tool's face examined with stereoscope
